Manhole Inspection Summary

Manhole # S25EE1036MH

Insp Date: **1/23/07 10:12 AM**

Location Address: **3940 HICKORY AVE**

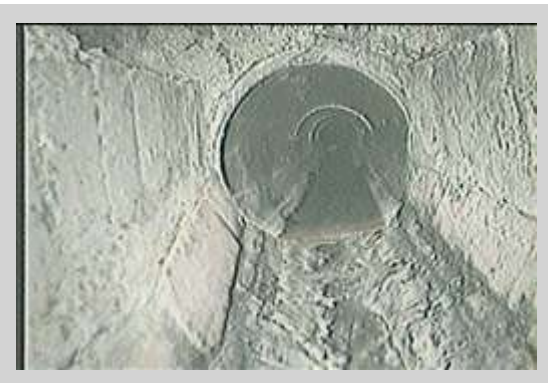
Pipe In @ 6 O'Clock

8 in. Circular Gravity Sewer

Rod and Bar (Angled)

Pipe Material: **Clay** ☐ Pipe Lined

Infiltration: **None** Pipe Seal Cond: **Unknown**
